**RECONSTRUCTION OF EVENTS LEADING TO THE CRASH OF NIMROD**

**XV 230 ON 02 SEPTEMBER 2006**

## **ACTIONS TAKEN TO REDUCE RISK TO NIMROD OPERATIONS**

## **OVERVIEW OF THE BOARD'S FINDINGS<sup>2</sup>**

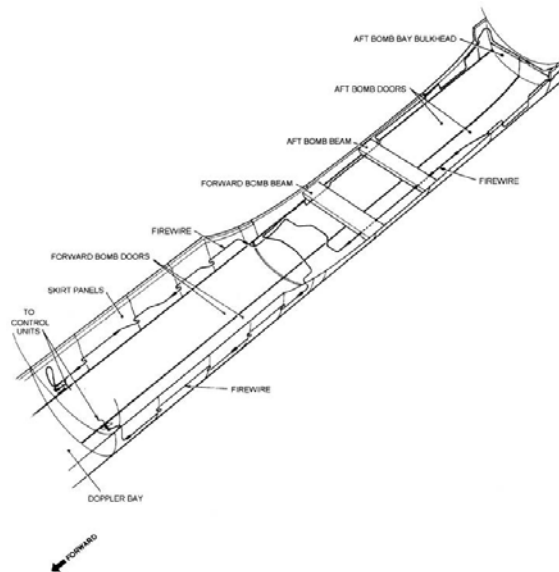
**Fig 1:**

A 'fire-wire' runs around the perimeter of the bomb bay (**Fig. 1**) and will activate visual and aural warnings in the aircraft cockpit if affected by heat.

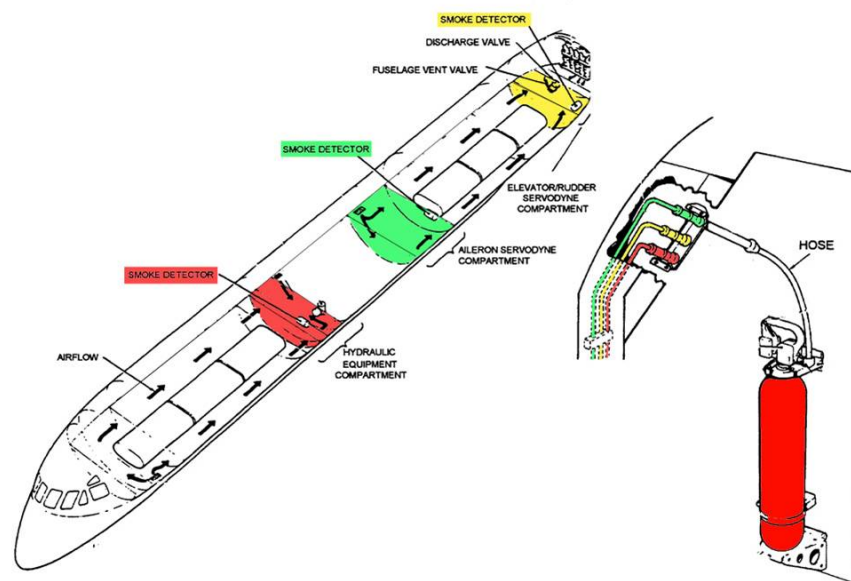
**Fig 2:**

Within the aircraft pressure hull, but under the cabin floor, are 3 under floor bays (**Fig 2**) each of which holds elements of the aircraft's hydraulic systems. As there is a fire risk inherent in any hydraulic system, each bay is fitted with a smoke detector and any can be connected to a fire extinguisher. All Nimrod crews practise dealing with smoke or a fire within these bays.
