ANECDOTAL INSTALLATION AND COMMISSIONING PROBLEMS

2.0 RAF Cottesmore

2.1 Background

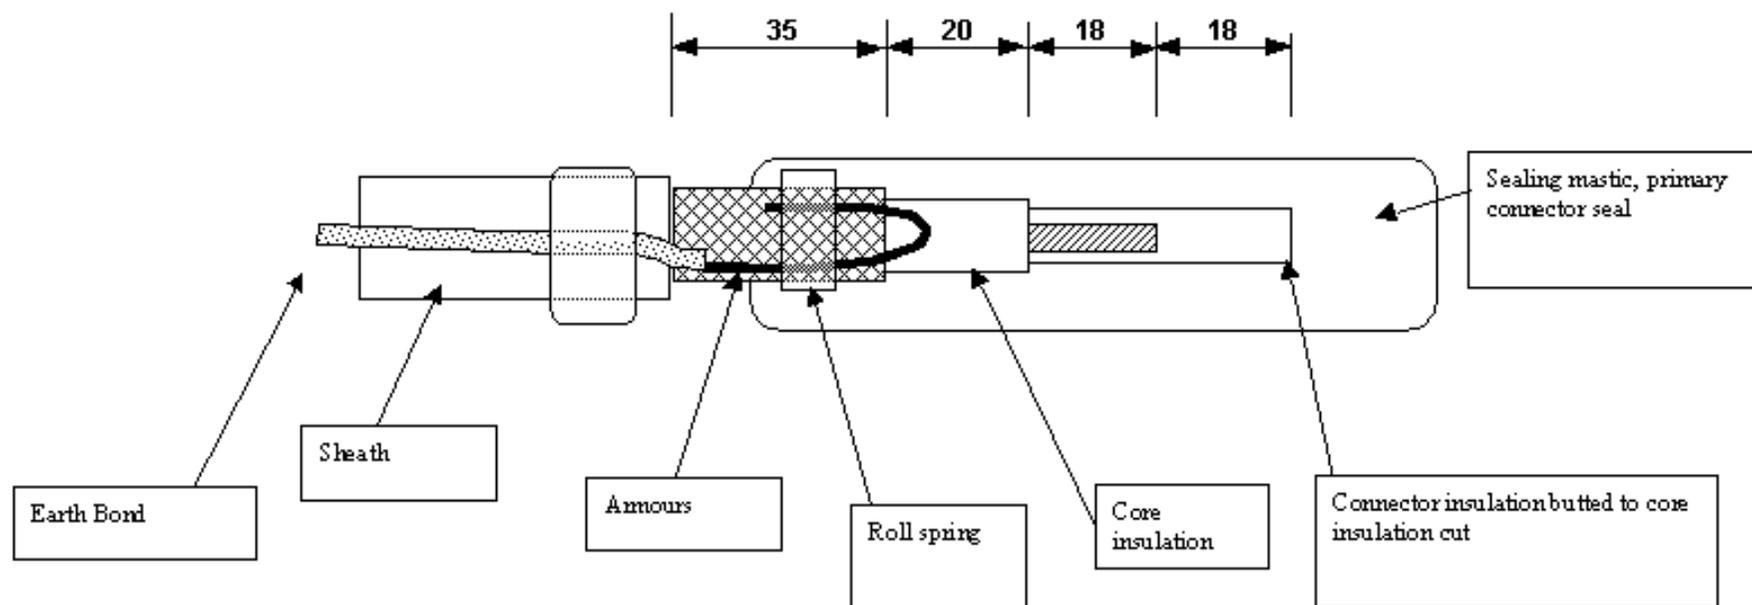
- 2.2.5. Figure 1 shows the joint assembly supplied for the approach lighting system; listed below are the areas of weakness.
- a. The earth bond comes within the primary connector water seal; therefore any water migrating along the earth wire has direct access to the connector if the seal fails.

- b. The assembly of the earth bond described in the jointing instruction can compromise the clearances between the end of the earth bond and the connector.

- c. The joint should be considered 'wet' until the end of the armours, as there is no water blocking under the sheath; therefore any sheath damage will result in water migration along the length of the cable. The dimensions given for the removal of the armours does not allow any margin for error especially coupled with point 2.2.4 b.

Figure 1; Dimensioned as drawn on jointing instruction. Outer heatshrink sleeve not shown.

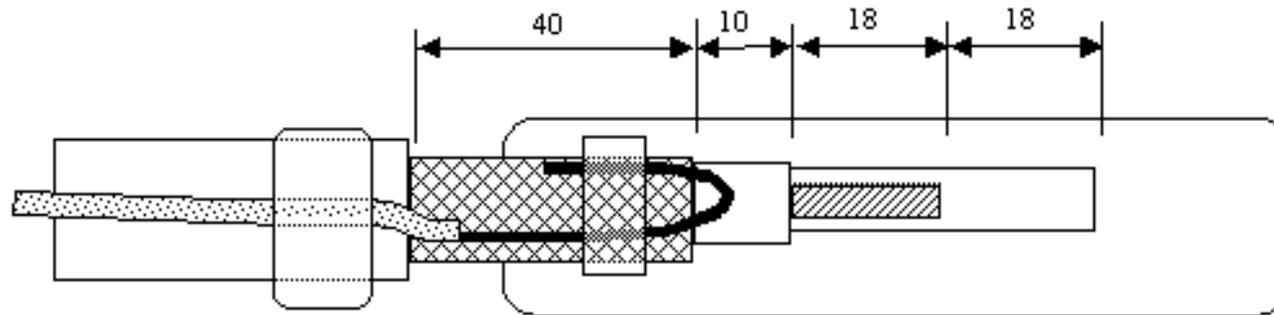
- d. A joiner working in the field would generally be expected to work within +/- 5mm, the length of core insulation available for sealing is therefore inadequate. *See Figure 2*

Figure 2. Drawing showing 5 mm error to two dimensions.

On the above drawing the sheath has been cut back 5 mm short and the armours 5 mm long, this reduces the insulation cut back to 10 mm due to the need to fit the connector equidistant either side of the centreline. The requirement to bend the earth wire back and incorporate it into the spring will further reduce the length of primary insulation available for sealing. Although the instruction specifies the spring position 15 mm from the sheath cut it is most likely to be fitted at the end of the armour cut. In the above case there would only be approximately 5 mm of primary insulation available for sealing after the bend in the earth wires.

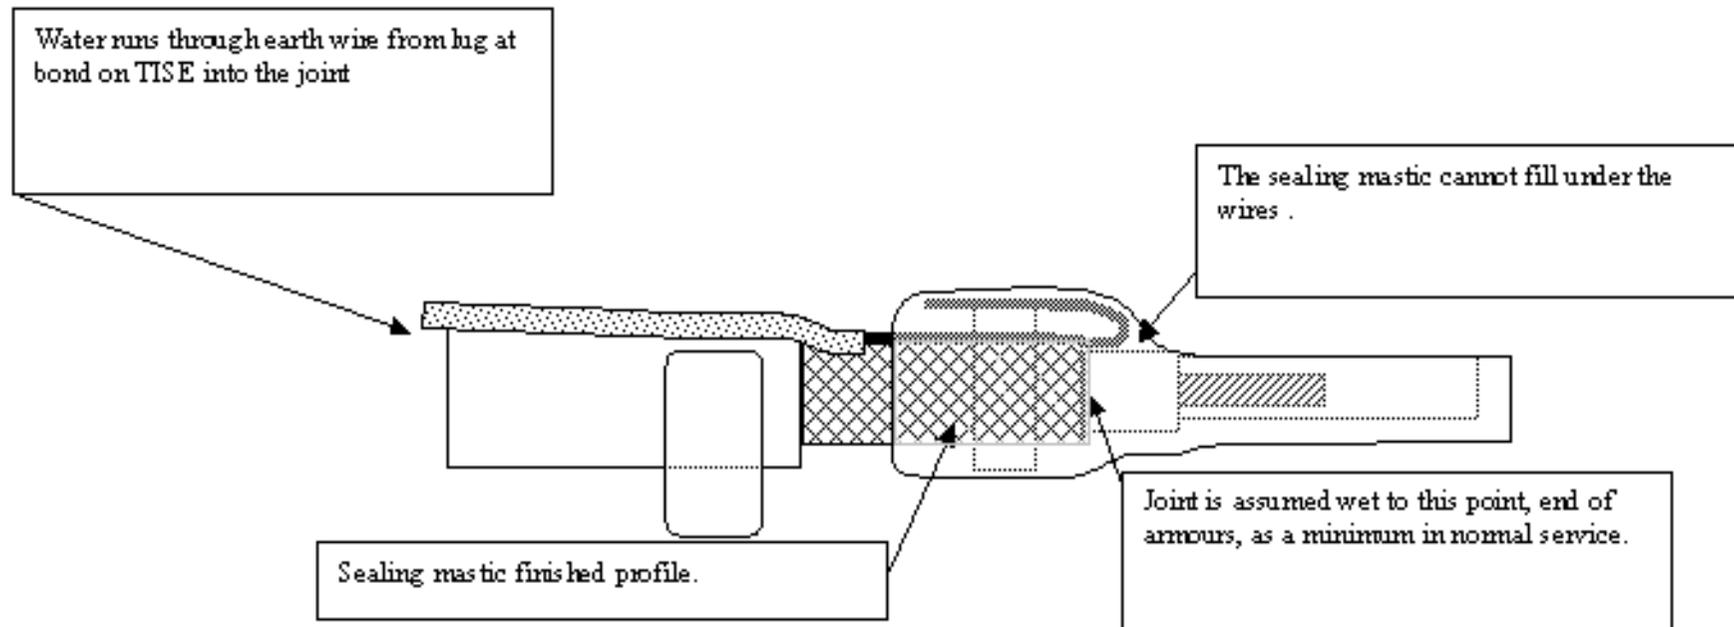
- f. The use of stranded earth wire for the external bond creates a 'pipe' to the inside of the joint. If the external end of the earth wire is not sealed any water in the ground will be drawn into the joint. *See point 2.2.4 a and Figure 3.*

Figure 3. Joint assembly ,Figure 2, shown in profile.

The outer heatshrink sleeve will follow the same profile as shown for the mastic at the end of the earth wire. The sealing mastic will not seal the earth wires nor will it seal onto the primary insulation under the bend in the wires. As well as water migrating along the earth wire into the joint, any sheath damage will result in water migrating to the end of the armours. The bond of the sealing mastic to the primary insulation will be relatively weak in the first 5 mm after earth bond, as the recovery of the heatshrink outer will follow a catenary, the low pressure seal coupled with load cycling will not withstand water at 1 m head for very long.

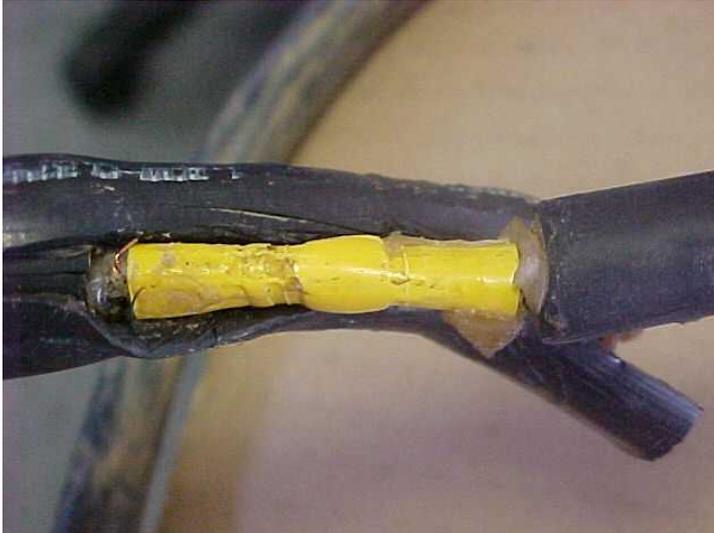
- 2.2.3. Examination of the joints returned with the TISE's from AWE showed that they had not been made in accordance with the manufacture's instruction. The black sealing mastic had not been applied to the connector/primary insulation. Therefore any water under the sheath of the primary tails due to a faulty bonding joint would have immediate contact with the conductor.

Picture of connector showing no evidence of black sealant and outer sheath intact at insulation cut.

- 2.4.1. The joints on the Runway 23 approach should be replaced with a more robust system.
- 2.4.2. The installing electricians/jointers should undergo manufactures training on the selected jointing system. The failure to assemble the straight joints correctly and the poor heat shrinking show that at least some refresher training is needed.
- 2.4.3. The electricians/jointers should be supplied with appropriate gas torches:

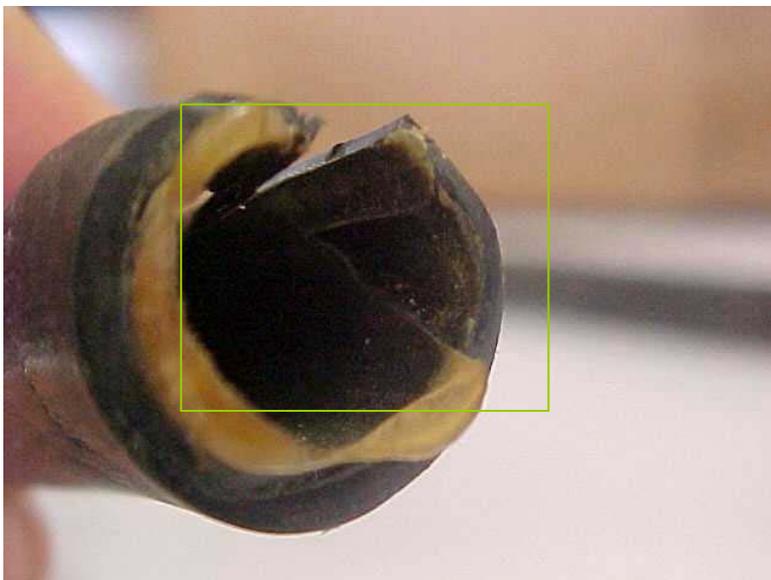
- 2.2.4. It was also noted that the outer protection heat shrink had not been evenly shrunk. One side of the tube was fully recovered while the other side showed minimal to zero recovery. This can only be attributed to a lack of heat and therefore the hot melt adhesive would not have activated. (See photographs appendix 1). On one of the returned joints the outer sheath had not been removed and had been cut flush with the insulation removal position.

Picture showing hot melt adhesive that has not flowed, in green square.

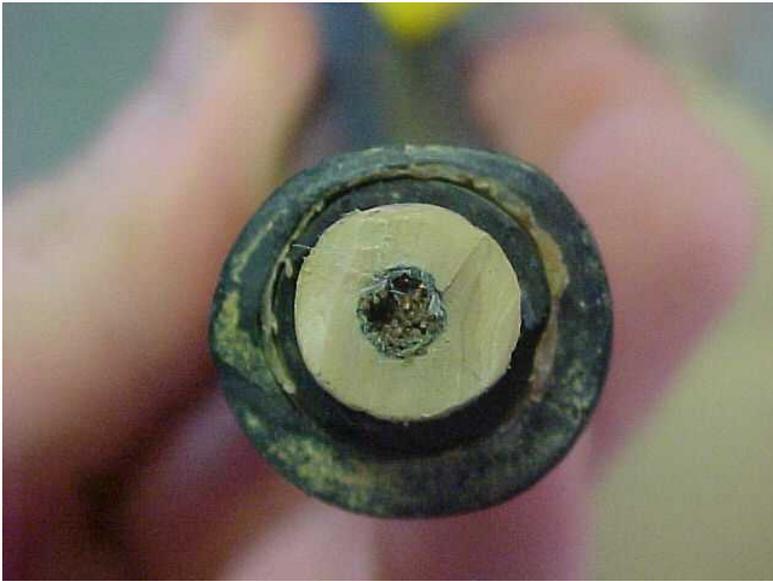
Picture showing non uniform shrinkage.
