Derailment of Gatwick Express Train near Redhill, Surrey on Monday 30 June 2003

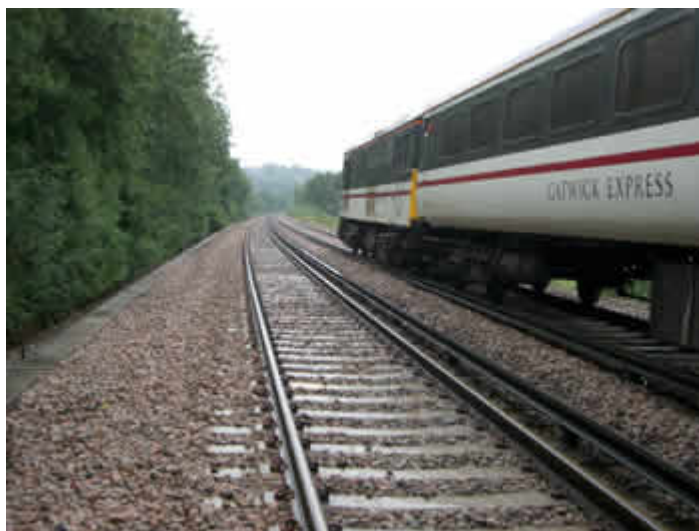
2. The train was traveling between 75 and 80 mph, which was within the permitted line speed, when the driver saw ahead a misalignment of the track; he immediately applied the emergency brake. As the train hit the track misalignment the driver was thrown from his seat, but he was not hurt. He promptly spoke to the signaller to get the line blocked and then placed track circuit operating clips and detonators on the line. One member of the public aggravated a previous whiplash injury. The train stopped 600m beyond the track misalignment. A single wheel set on the leading bogie of the locomotive was derailed. The passengers were evacuated into another train brought alongside at 8.30 am.

Derailed trailing locomotive

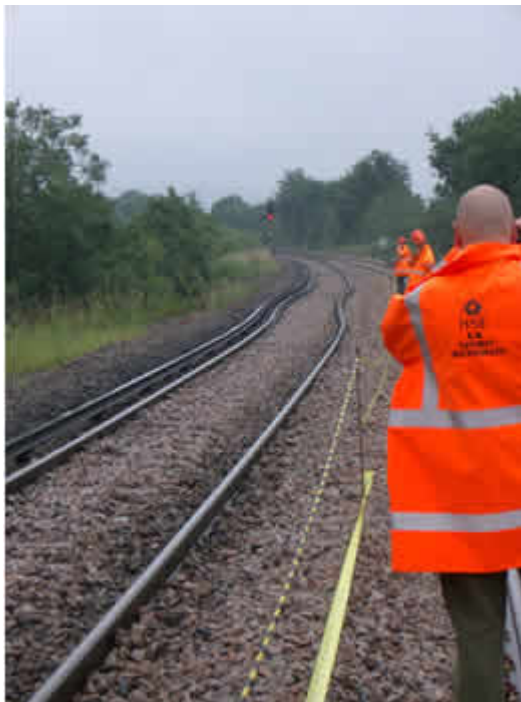
Track fault after the Gatwick Express had travelled over it

5. Examination of the track confirmed that, immediately to the south of the derailment site, the Up line track had been progressively displaced towards the Down line track by up to 228mm. This displacement occurred over a length of 171 sleepers. The derailment was caused by the sharp transition in the track's alignment between the displaced and undisplaced sections of line. The trailing Class 73 Electro Diesel locomotive caused the track displacement towards the cess, as shown in the photograph above, after it had been through the sharp transition.

6. A number of different scenarios have been examined to determine how the track could have been displaced in this way. The only reasonable explanation for the displacement lies in the tamping work carried out on the day of the

incident. After extensive examination no permanent fault could be found with the tamper and while a transient fault in the tamper's slewing mechanism could not be replicated, it may have been present.

7. The tamper was not pulled off the transition in the track between the displaced and undisplaced sections of line at the end of the tamping run to allow the track to be inspected. This failure to properly inspect the transition at the end of the tamping run before handing it back for use has been raised with Network Rail (the infrastructure controller) and AMEC SPIE Rail (UK) Ltd (the infrastructure maintenance contractor, who had responsibility for inspection of the track) and Jarvis (the tamper's owner and operator). Very soon after the incident both companies sent out briefings to their staff to ensure that tampers are moved off the end of their working area to enable the proper inspection of the transition area prior to a return to service. HMRI is content with that action by both companies. HMRI will not be making any further comment on this investigation, which has been closed out.
