## INFORMATION NOTE

### Delmatic Lighting Controller Modules

Number: IN 07/09

Date of issue: 10<sup>th</sup> July 2009

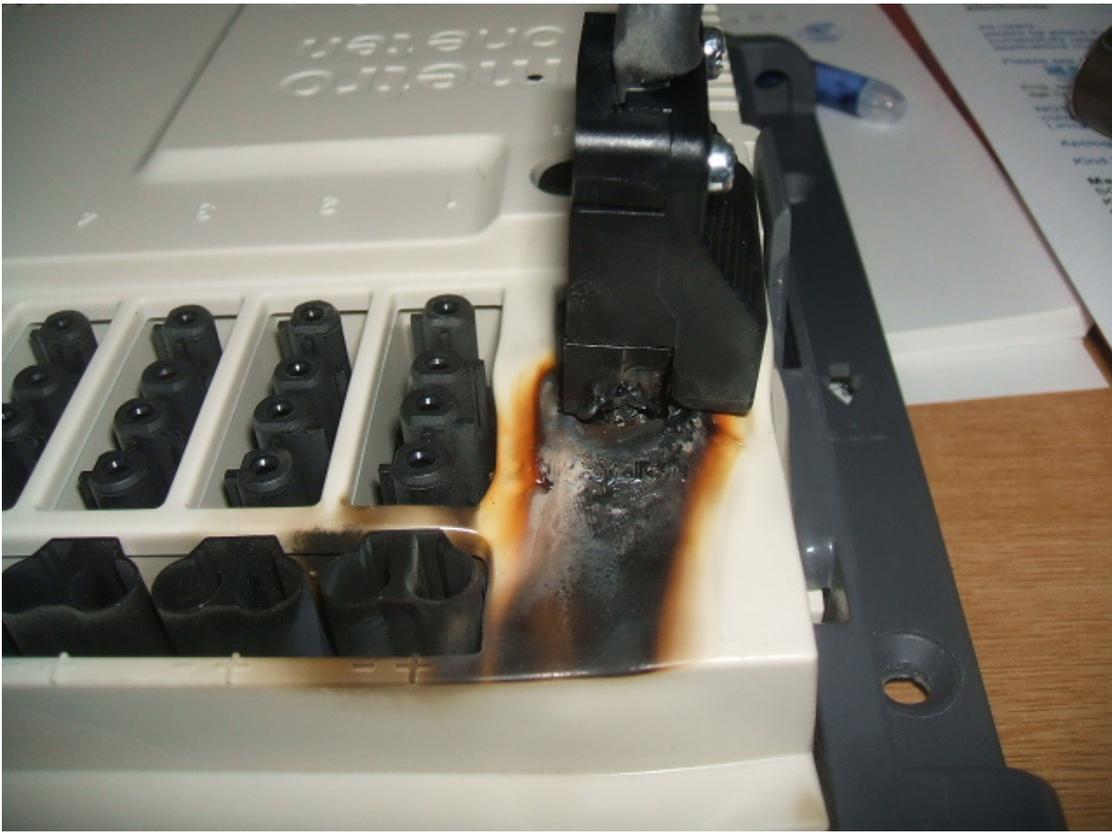
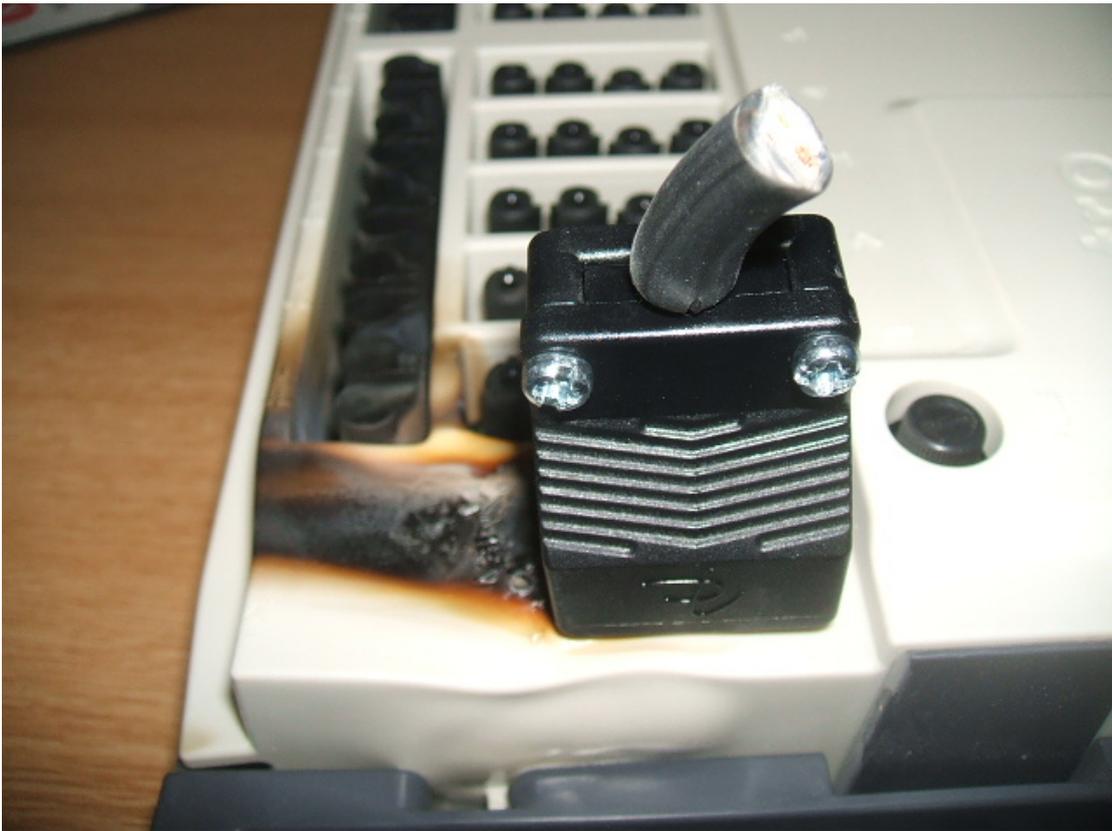
1. A Site has experienced burning out of quantity 3 Delmatic Metro One Ten lighting controller modules from an installed total of 150 identical modules. Photographs of the damaged modules are attached along with the manufacturer's report.
2. On investigating the incident the manufacturer observed that some of the connector pins inside the mains power connector had blackened. The blackening was caused by electrical arcing which occurred due to loose fitting of the counter connector part. This black deposit acts as high resistance thus inducing failures in the affected modules.
3. The manufacturer has concluded that the situation arose as a result of improper installation of the mains power connector.

During the inspection, it was noticed that some of the connector pins inside the mains power connector had blackened, whereas other pins within the same connector were seen to be clean. It has been established that the blackening was caused by the electrical arc due to loose fitting of the counter connector part, too much of this black deposit on the connector pin acts as a high resistance making the module fail to operate. This is due to an installation fault.

4. To prevent the problem from occurring the manufacturer has recommended the following course of action:
  - 4.1 The connectors must be fitted firmly to their counter connector parts.

- 4.2 The supply cable must have enough slack prior to securing them to the frame of the module with the cable ties. This ensures that the connectors are not under tension and prevents skewing and partial withdrawing of the connectors from their counter connector parts, thus eliminating the chance of arcing to occur.

- All the connectors must be fitted firmly to their counter connector parts on the modules.
- The cable at the module end must have enough slack prior to securing them to the frame of the module with the cable ties, this to ensure that the connectors are not under any tension. This will stop skewing and partial withdrawing of the connectors from their counter connector parts on the module, eliminating any chance of arcing to occur.
