## Torwood Broch

The broch at Torwood near Falkirk was recently the focus of a conservation project undertaken by Archaeology Scotland with grant aid from Forestry Commission Scotland. Under the guidance of Archaeology Scotland's *Adopt-a-Monument* team (and the Local Authority Archaeology Service), local volunteers cleared the broch of scrub vegetation and naturally regenerating trees. The exposed drystone masonry and surrounding earthworks were then subject to a detailed archaeological measured survey by laser scanner.

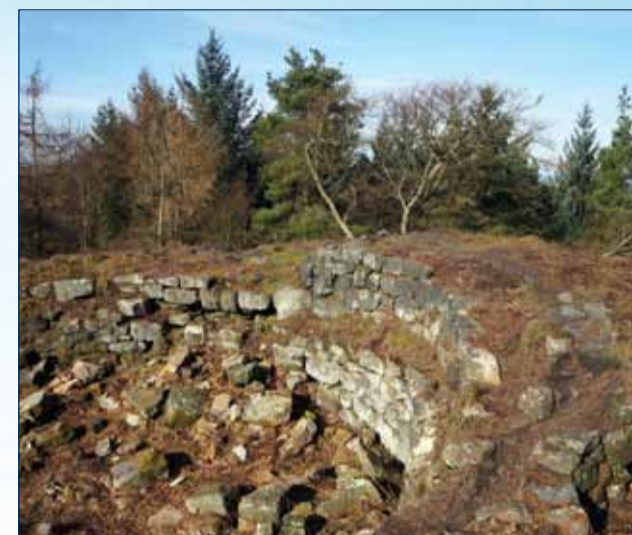
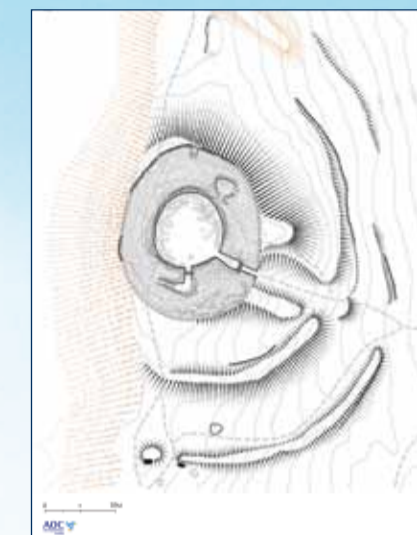
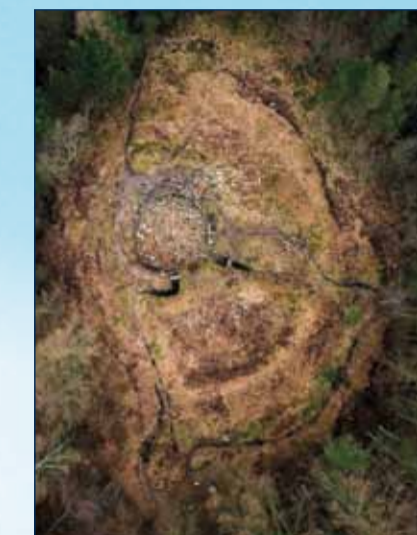
The archaeological measured survey has created a detailed and comprehensive record, providing images that can be used in management planning (such as Forest Plans), condition monitoring and public interpretation. For example, the traditional archaeological plan includes conservation issues such as the routes of the various paths that cross the site – essential information that informs ongoing condition monitoring. Low altitude aerial photography by microcopter can provide even greater illustrative detail.

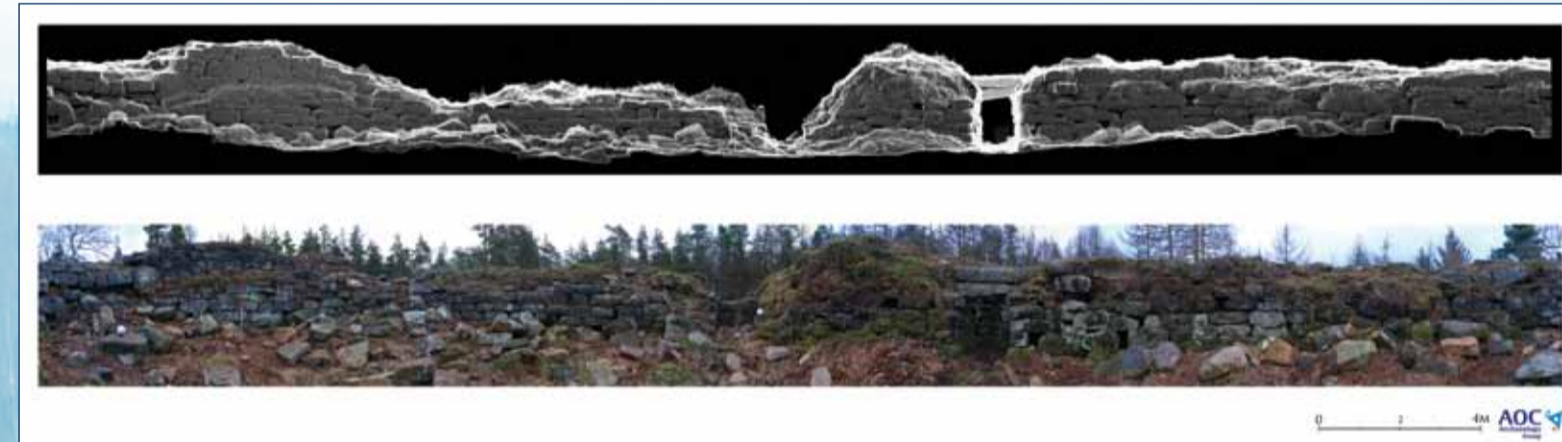
Laser scanning can be used to produce accurate and informative visualisations on plan, in section and as 3D models. The innovative interior elevation and illustrative photographic panorama both record architectural features such as the stonework, scarpement, recesses, lintels and entrance passage. The conservation project has also demonstrated the best-practice UK Forestry Standard *Forests and Historic Environment* guidelines in action.
