MAINTENANCE & SAFETY CHECKS
GENERALY

ANNEX L.....
to TDS No.29 Issue 2
Range Works Inspection Guide

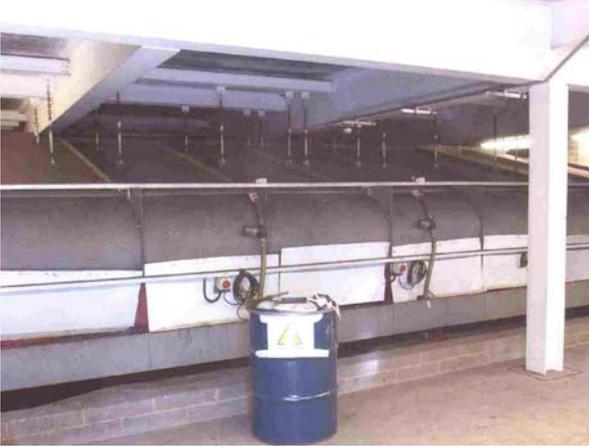
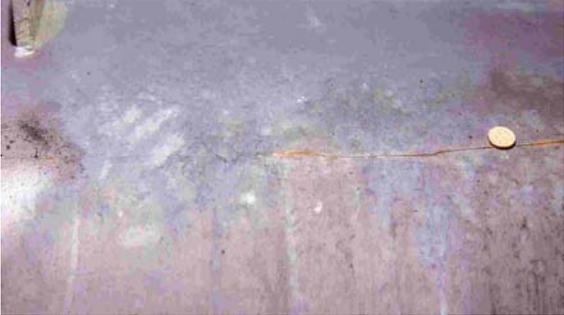
Ser	Element	Remarks		
1.	Snail traps - fabrication failure stress cracking.	<p>In the process of bending the steel if the rate of bend exceeds the design rate stress cracks may form on the outside of the curved steel elements.</p>

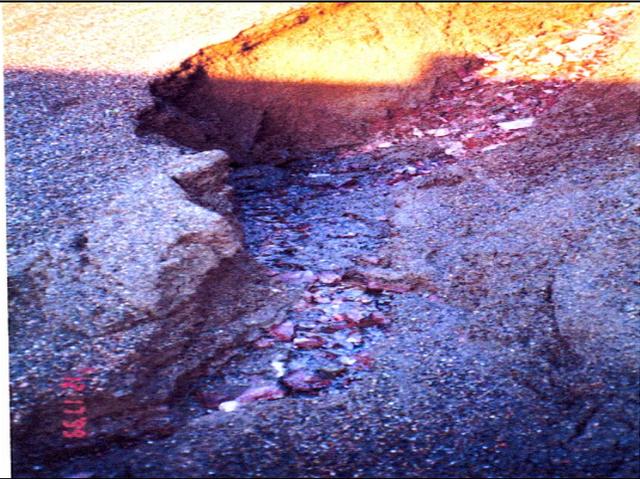
2.	Sand specification	<p>JSP 403 Vol.2 calls for a particular banding for stability of slope. The BS refers also to mechanical properties that many suppliers seem to ignore. The specified grading with correct mechanical properties provides a stable slope in all weathers.</p>

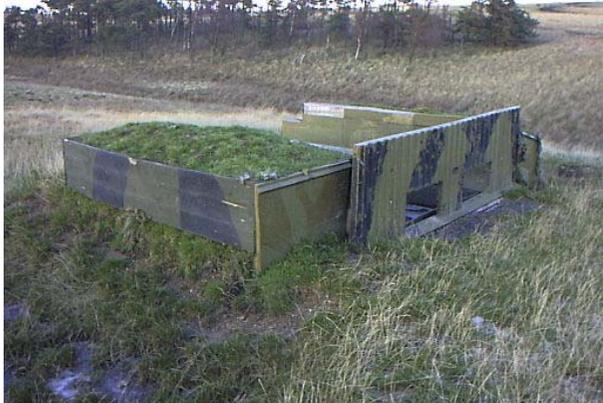
3.	Sand slopes	Stop butts constructed entirely of sand are ballistically safe but stability during extreme wet weather must be considered. Timber frames or geogrids are suitable clear of the bullet impact areas.		
3.	Drainage	Drainage is an important safety feature where grenades or rockets are used. A flooded pit or depression may hide blinds making it dangerous for the RCO to clear.

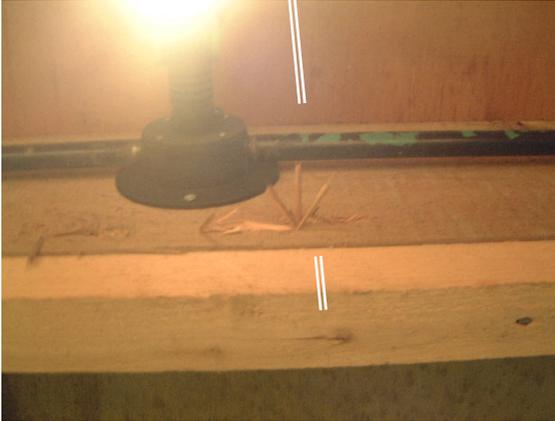
4.	Bullet damage	<p>The RAO annual inspector will determine why shot occurs in unexpected areas. He may not however look at the stability of damaged structural members or services.</p>

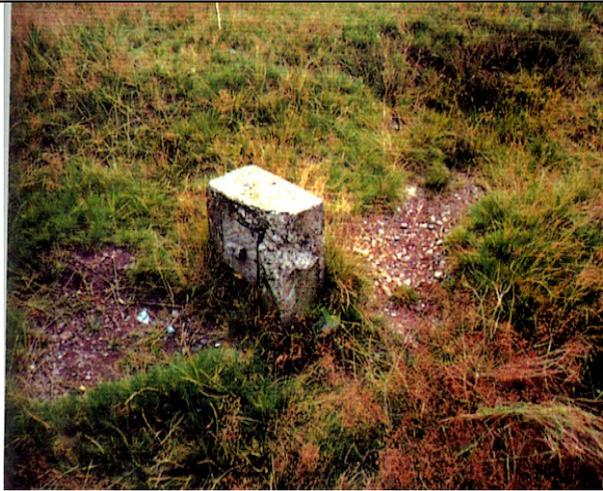
<p>Steel columns</p>
5.	Structures on ranges	<p>Cable pit or service markers made of a hard material on ranges must not be exposed to direct fire.</p>

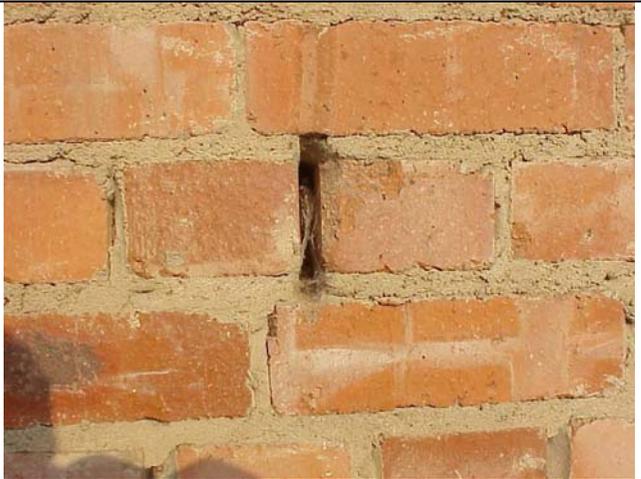
6.	Weakened defence structures.	Where walls provide ballistic protection, leaving dry joints or using hollow blocks or brick is dangerous.

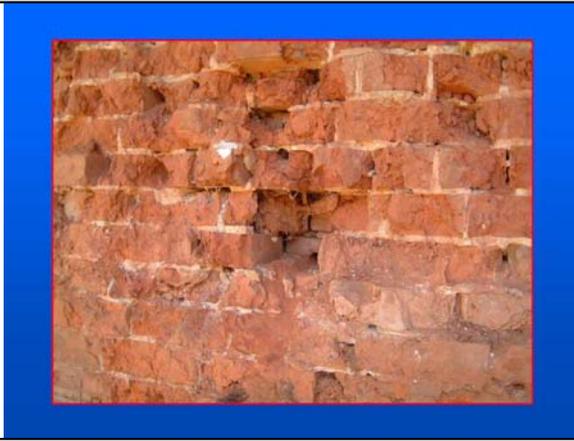
7.	Hidden attrition – also looked at by annual and independent inspectors.	Bullets pass through timber leaving a small hole that is not noticeable. The bullet loses all of its energy when it strikes a hard surface. Here is the effect well illustrated exposed when the works organisation eventually decided to replace the timber.
